# **Selected Images of the Effects of the October 15, 2006, Kīholo Bay-Māhukona, Hawai‘i, Earthquakes and Recovery Efforts**

Data Series 506

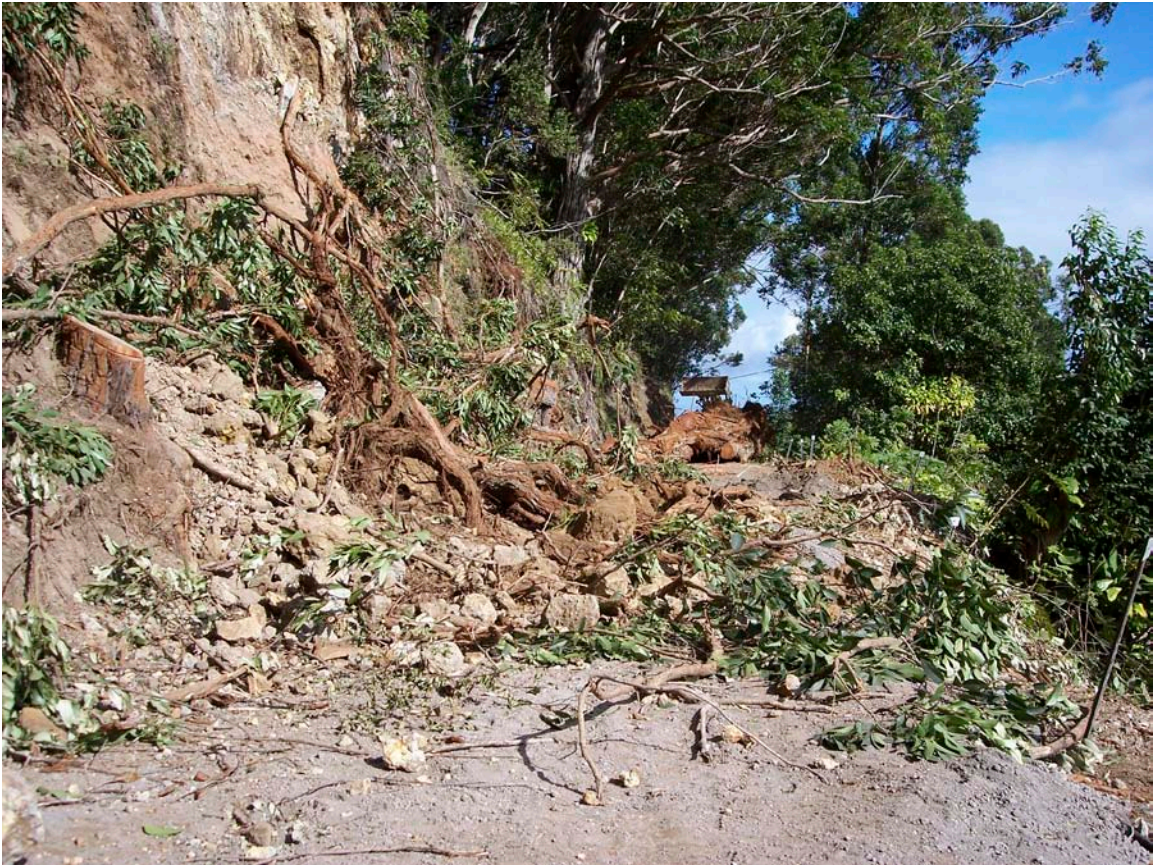
7.5. View of rocks, soil, and pruned or fallen trees on the narrow Sand Gulch Road (view to the north). USGS photo by T.J. Takahashi, 12/22/2006 (tjt2189).

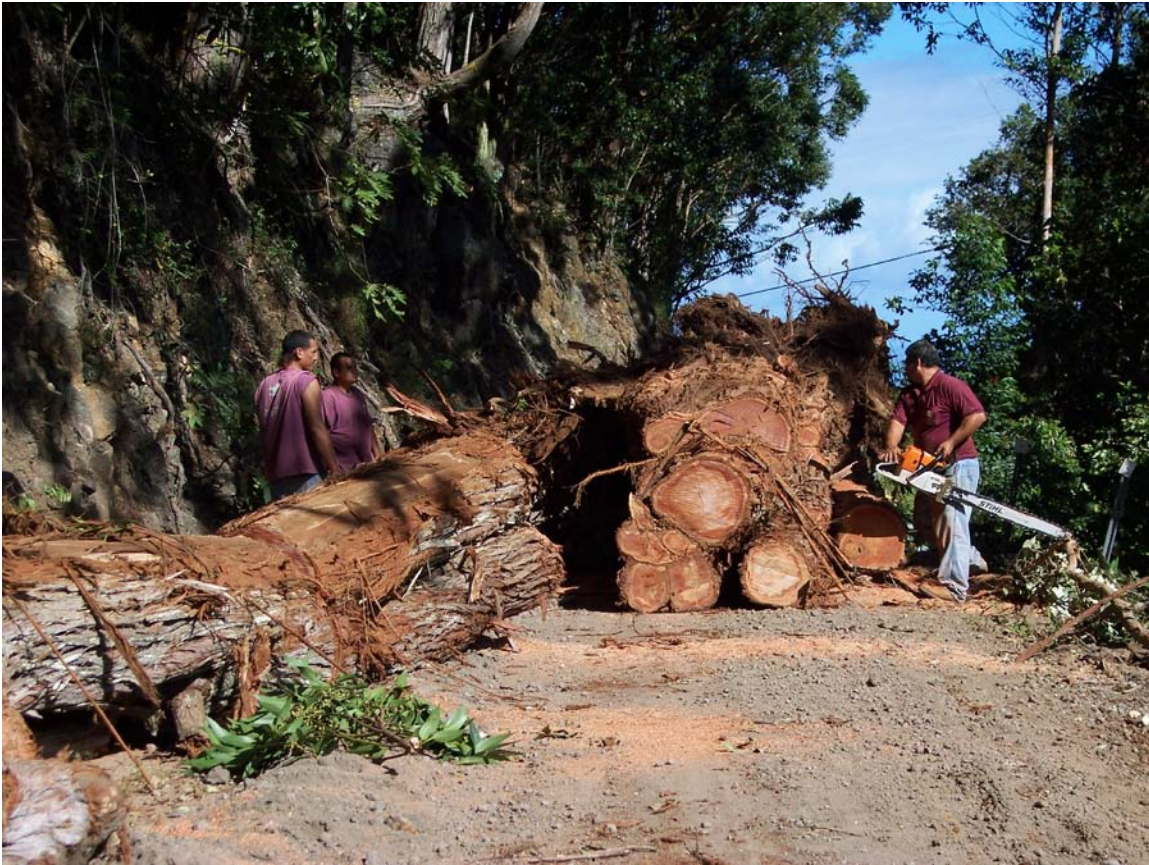
7.6. View of workers sawing and removing sections of the massive tree's multiple trunks, which are subject to fracturing in high winds. Due to the narrow, cracked road, moving the large tree sections and removing all debris to clear the road for safe passage were also hazardous (view to the north). USGS photo by T.J. Takahashi, 12/22/2006 (tjt2237).

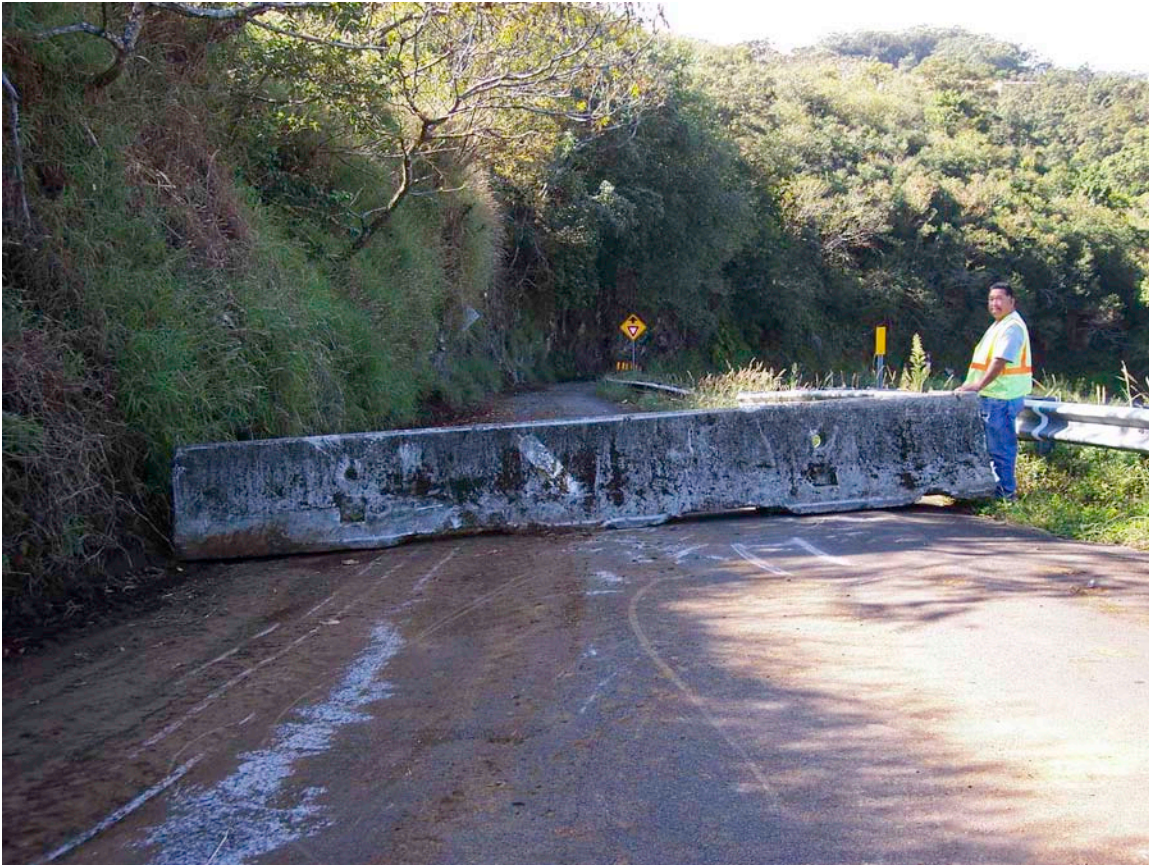
7.8. View of highway overseer, standing beside a concrete barrier blocking access to the damaged road. In the early phase of the road-clearing work, frustrated drivers removed wooden roadblocks to regain passage on the damaged road. Equally exasperated workers placed the large concrete roadblocks across the roadway to reduce the hazard for motorists and enabled them to get their work done (view to the southwest). USGS photo by T.J. Takahashi, 12/22/2006 (tjt2219).

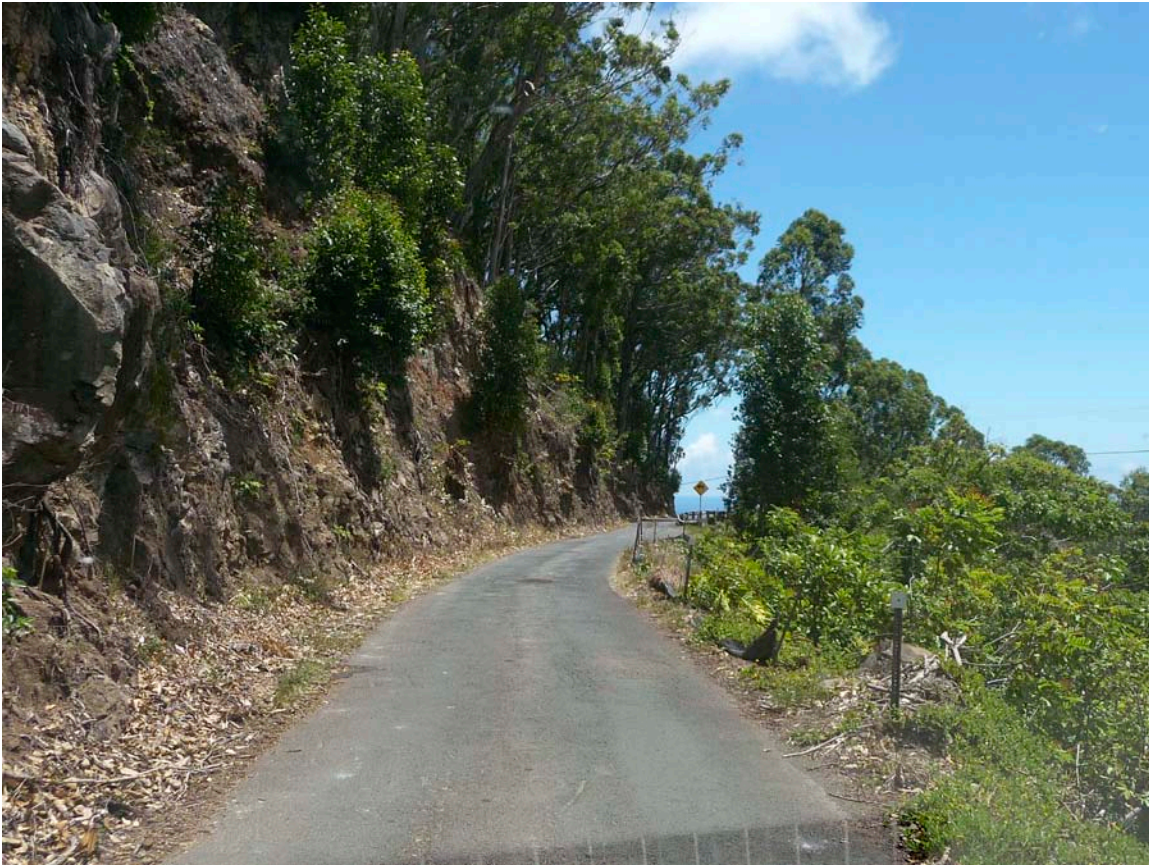
7.9. View of the one-lane road, finally cleared of trees, rocks, and debris, passable once more (view to the northeast). USGS photo by N.A. Ikeda, 7/11/2008 (nai596).

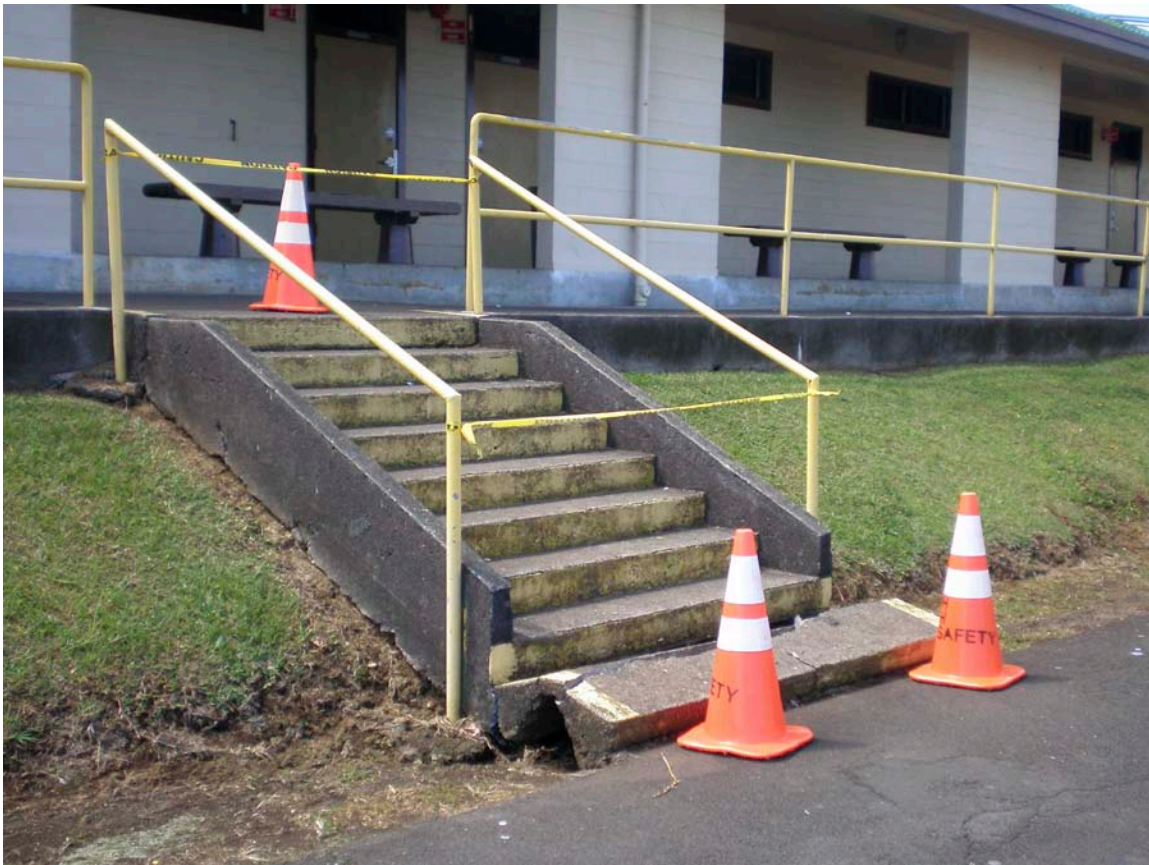
8.1. View of the concrete base of the stairway that buckled, cracked, and moved approximately 15.24 cm (~6 in.) to the northwest (view to the southwest). USGS photo by C. Francos, 10/17/2006 (cf022).

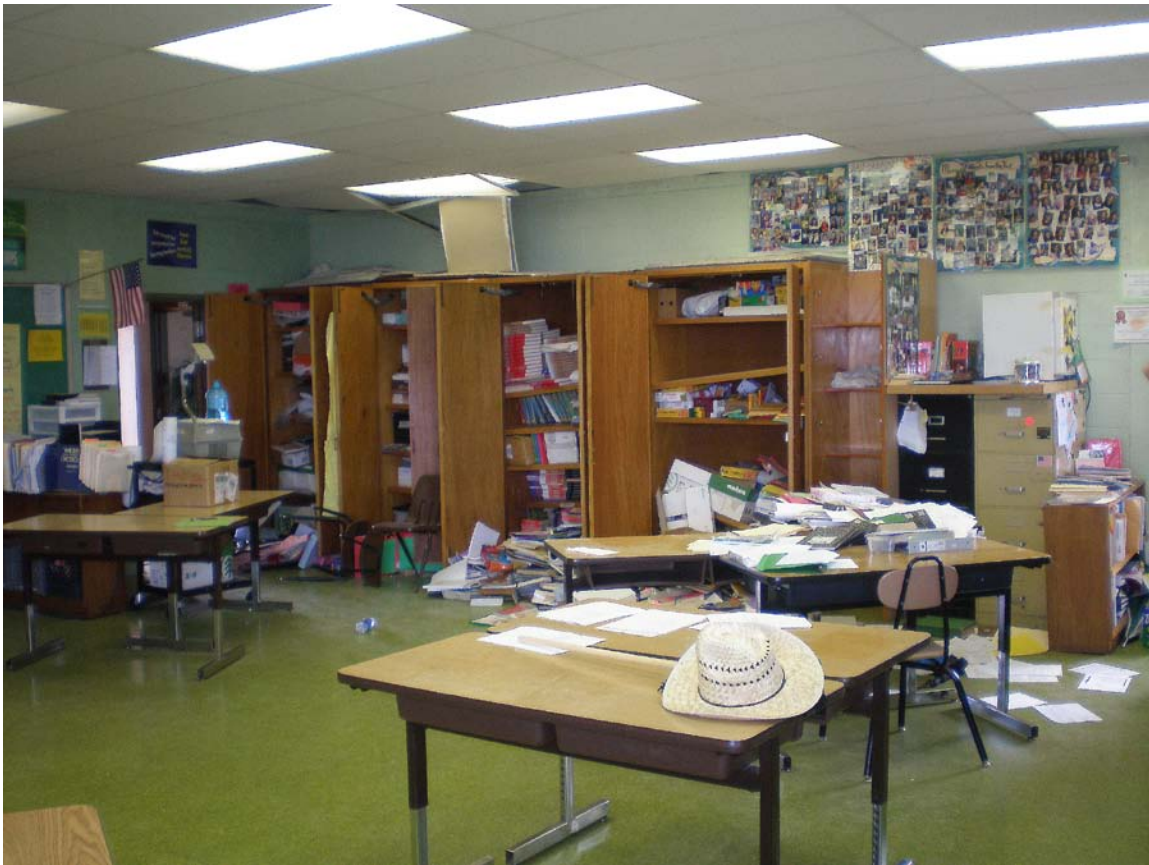
8.3. View of papers and books that spilled out when cabinet doors burst open during the earthquake. Cabinet shelves were dislodged, and papers and notebooks were disarrayed as desks skidded from their original positions in the room. Ceiling tiles crashed to the floor (photo angle not available). USGS photo by C. Francos, 10/17/2006 (cf025).

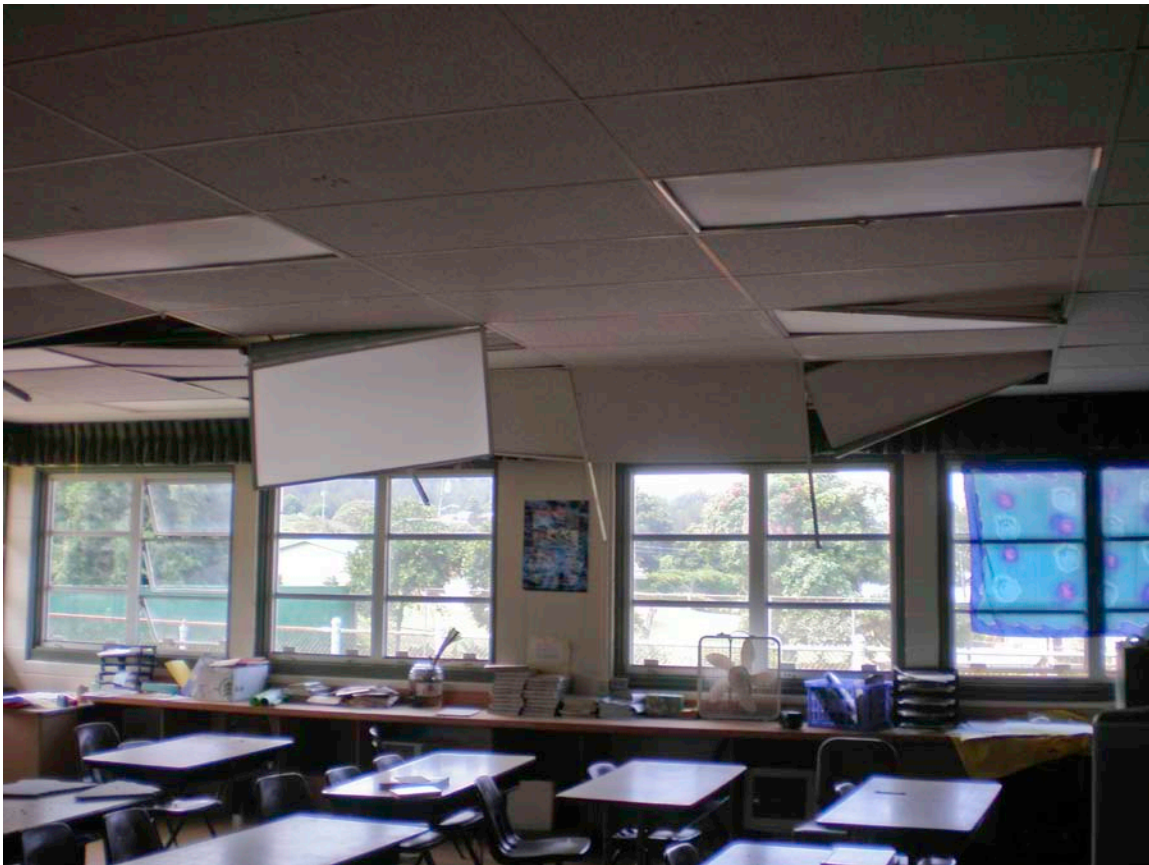
8.4. View of ceiling tiles, hanging precariously from the ceiling of an empty classroom (photo angle not available). USGS photo by C. Francos, 10/17/2006 (cf029).

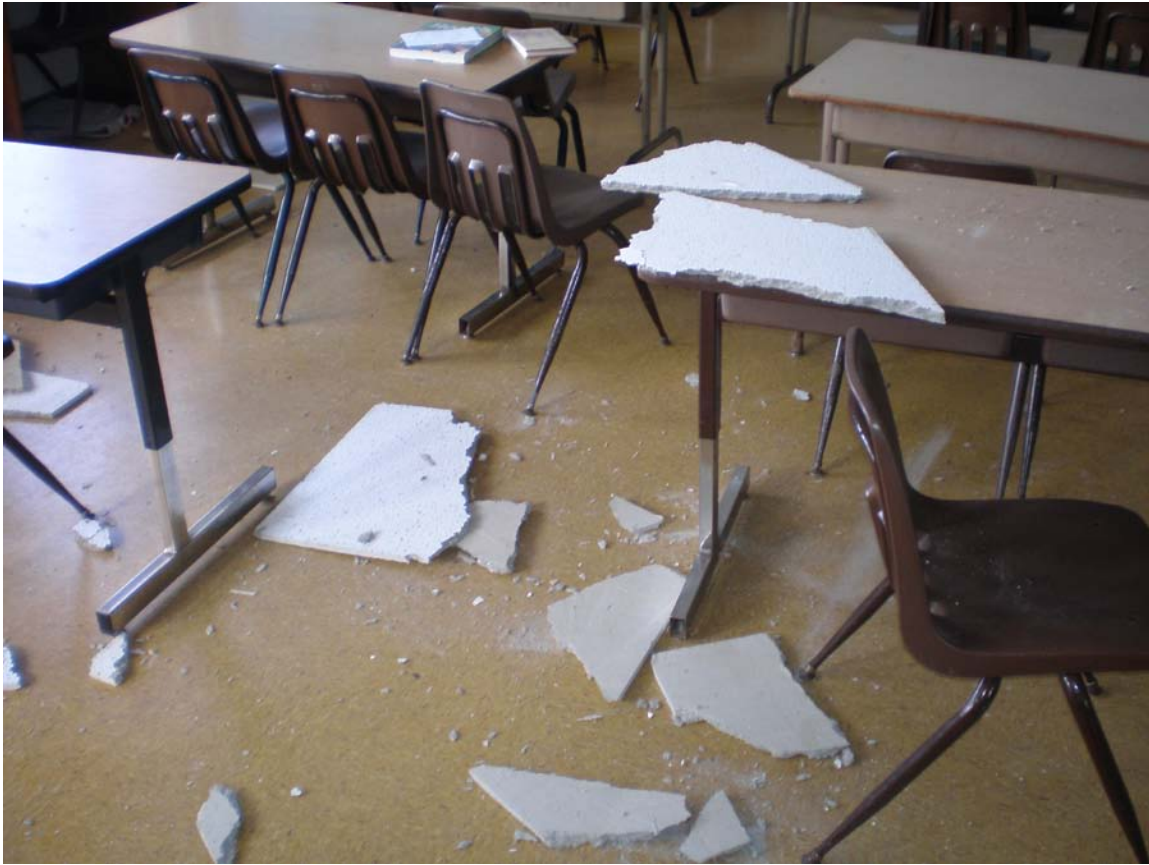
8.5. View of fragments of fallen ceiling tiles scattered across the floor of the classroom (photo angle not available). USGS photo by C. Francos, 10/17/2006 (cf031).

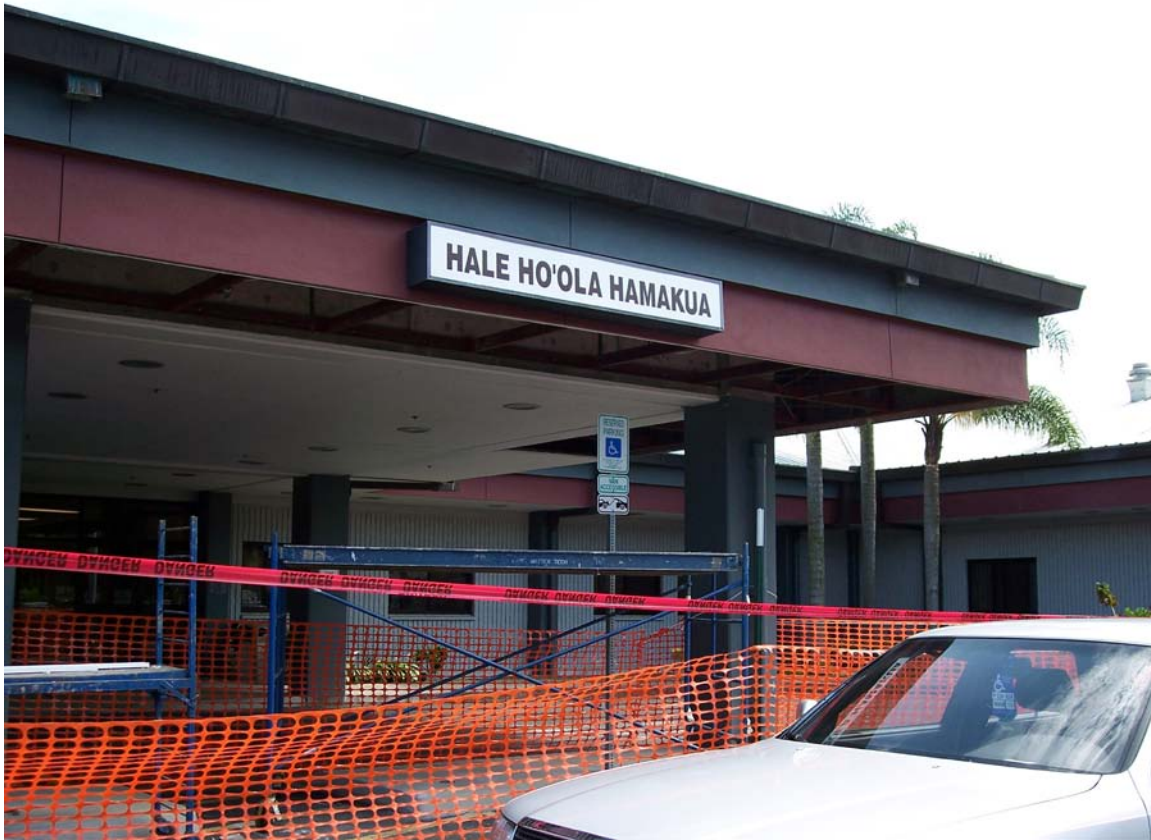
9.1. View of scaffolding and red tape (designation for structures unsafe to enter or occupy) that indicate the level of damage to Hale Ho‘ōla Hāmākua (view to the southwest). USGS photo by T.J. Takahashi, 10/20/2006 (tjt1332).

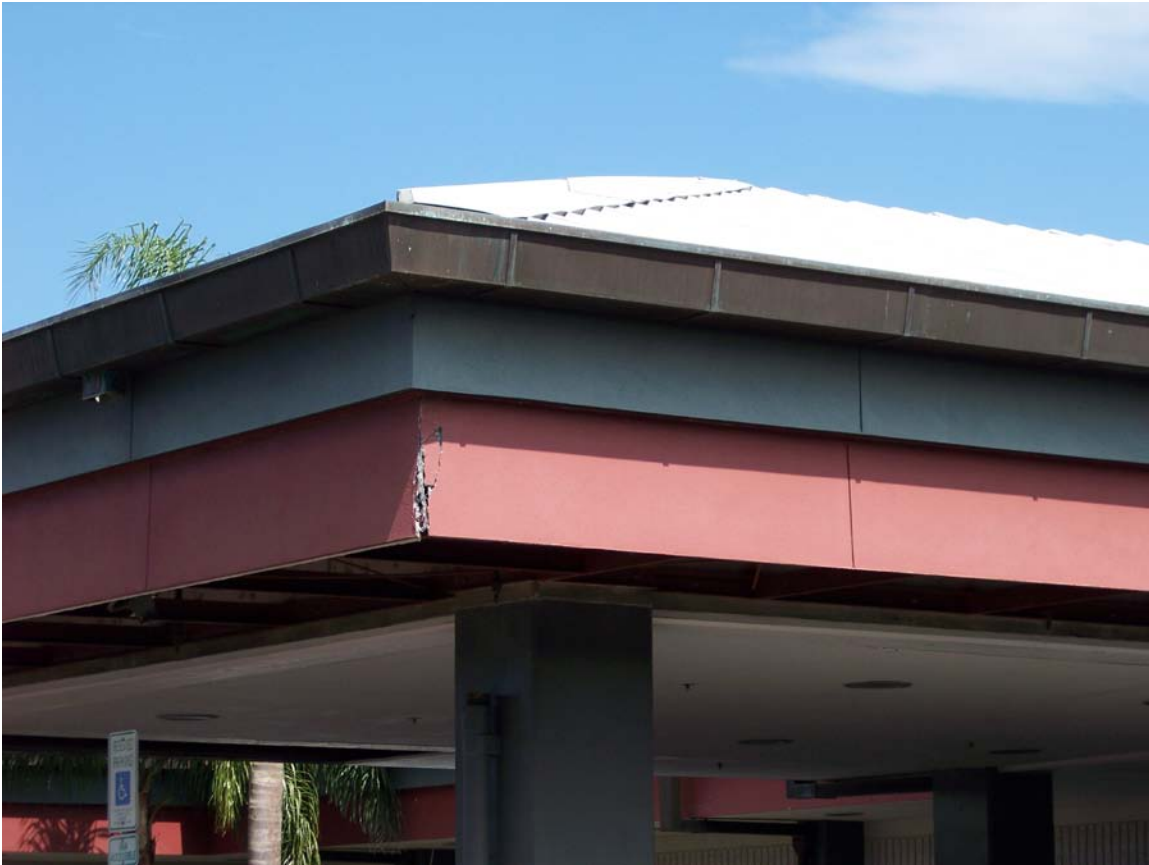
9.2. View of damage to the support beam's exterior corner joint under the eaves of the facility's covered entrance (view to the southeast). USGS photo by T.J. Takahashi, 10/20/2006 (tjt1348).

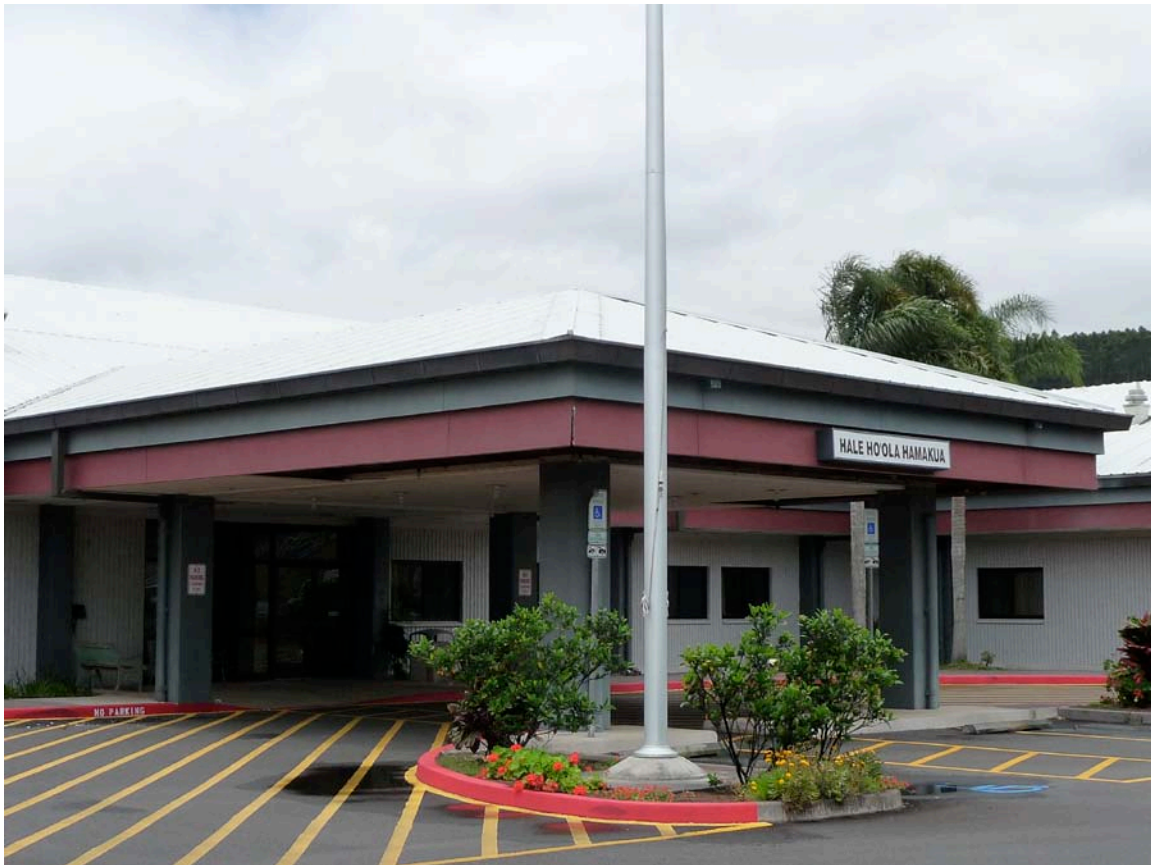
9.5. View of the partially repaired covered entrance and driveway awning (view to the west). USGS photo by N.A. Ikeda, 6/25/2008 (nai299).

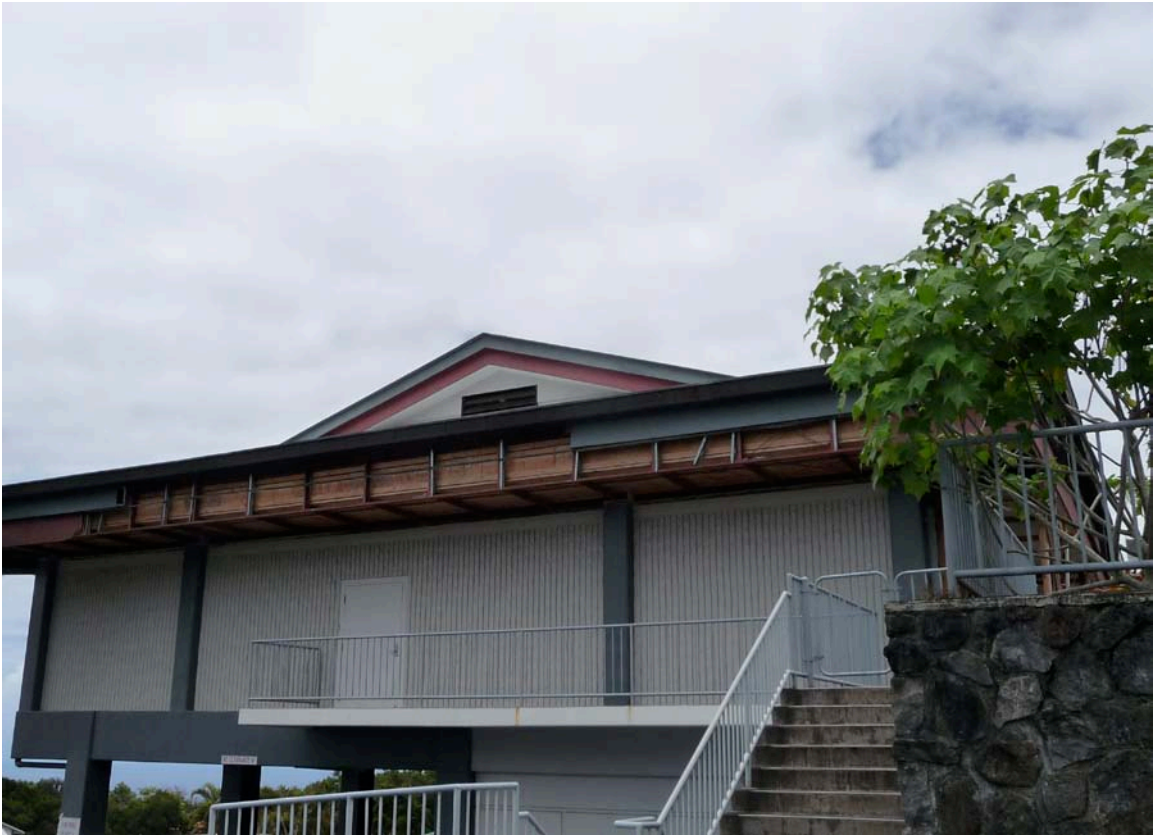
9.6. View of exterior repair work under the roof's eaves. Fallen panels were replaced with wooden boards (view to the east-northeast). USGS photo by N.A. Ikeda, 6/25/2008 (nai298).

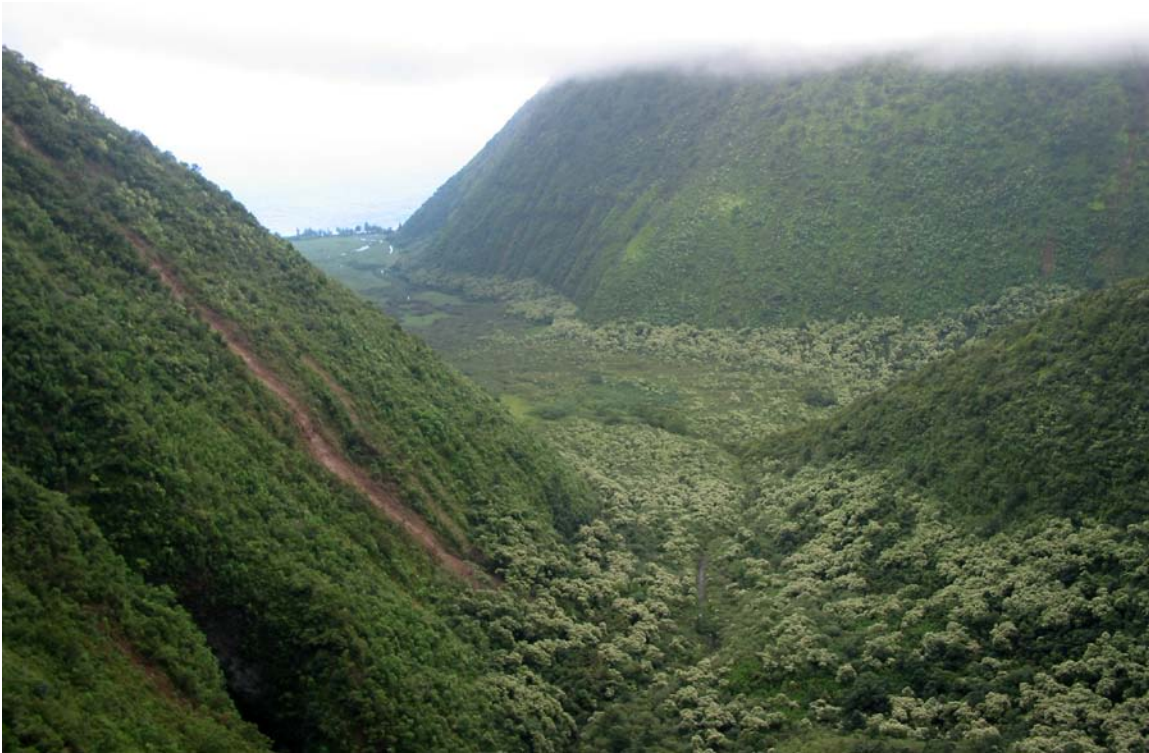
12.3. *Overview image:* Close-up aerial view of the scar left from rock and soil slides (left foreground in photo) at the head of the Waihilau Branch on the windward side of Waimanu Valley, looking toward the ocean (view to the northeast). USGS photo by J.P. Kauahikaua, 11/8/2006 (jpk5950).

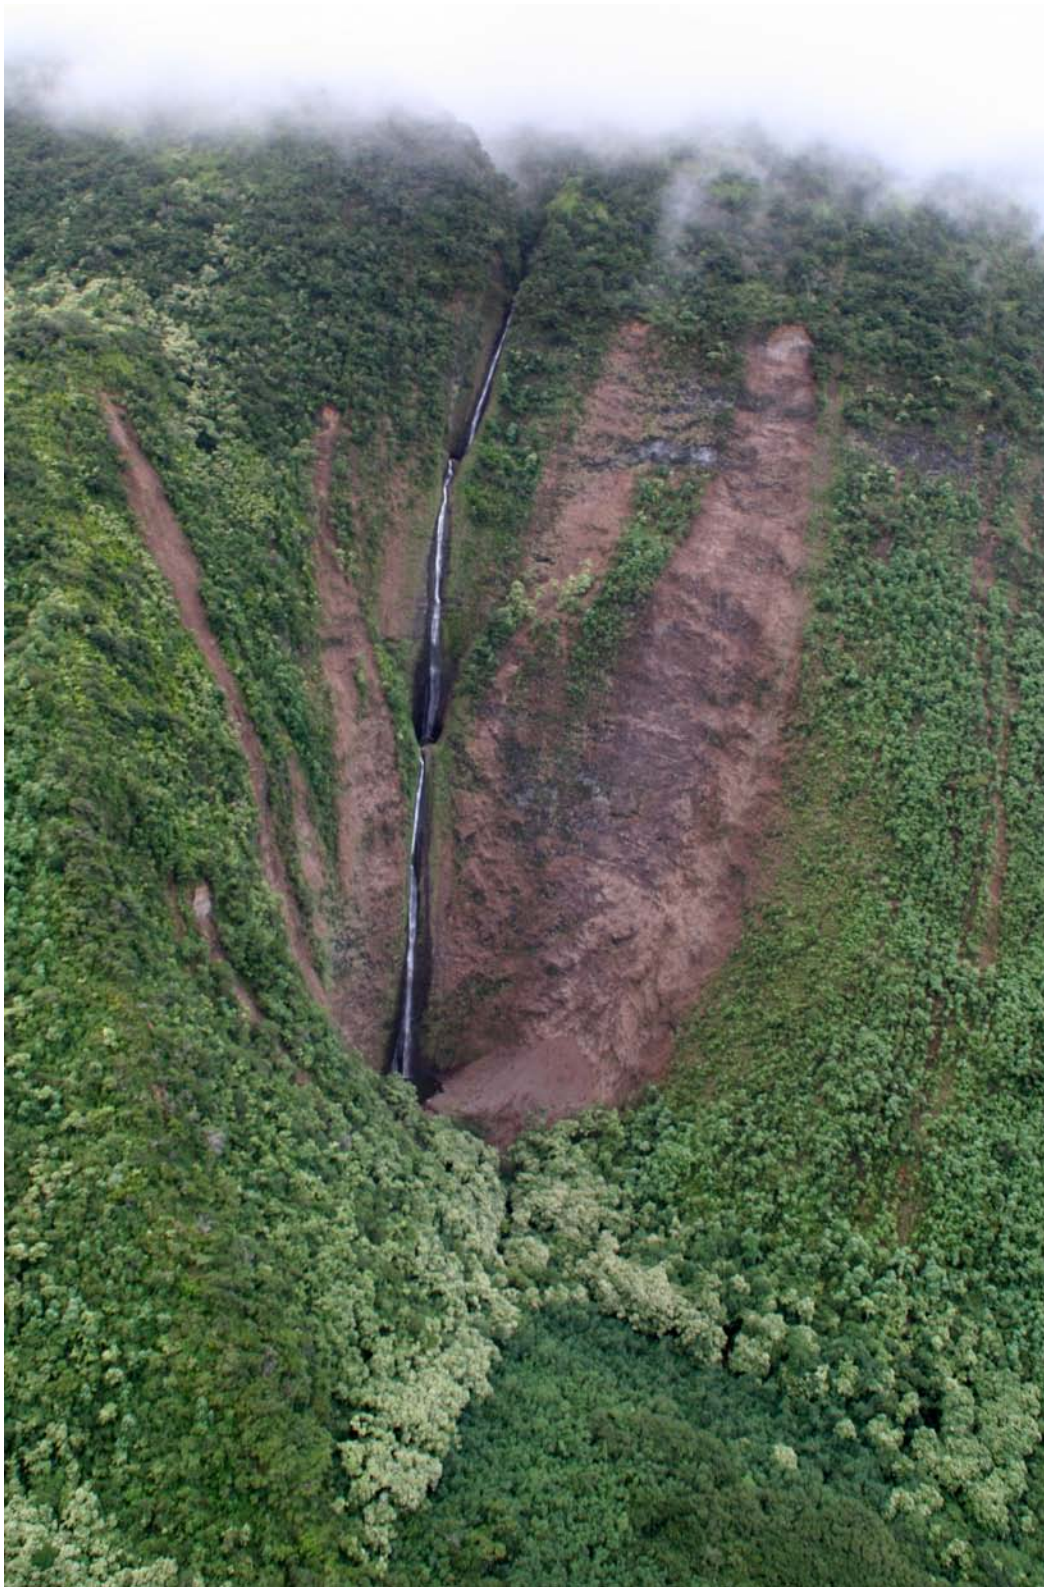
12.4. Aerial view of Wai'ilikahi Falls and Stream, surrounded by walls of vegetation scrubbed by shallow rock and soil slides (view to the west). USGS photo by E.L. Harp, 11/8/2006 (elh1187).

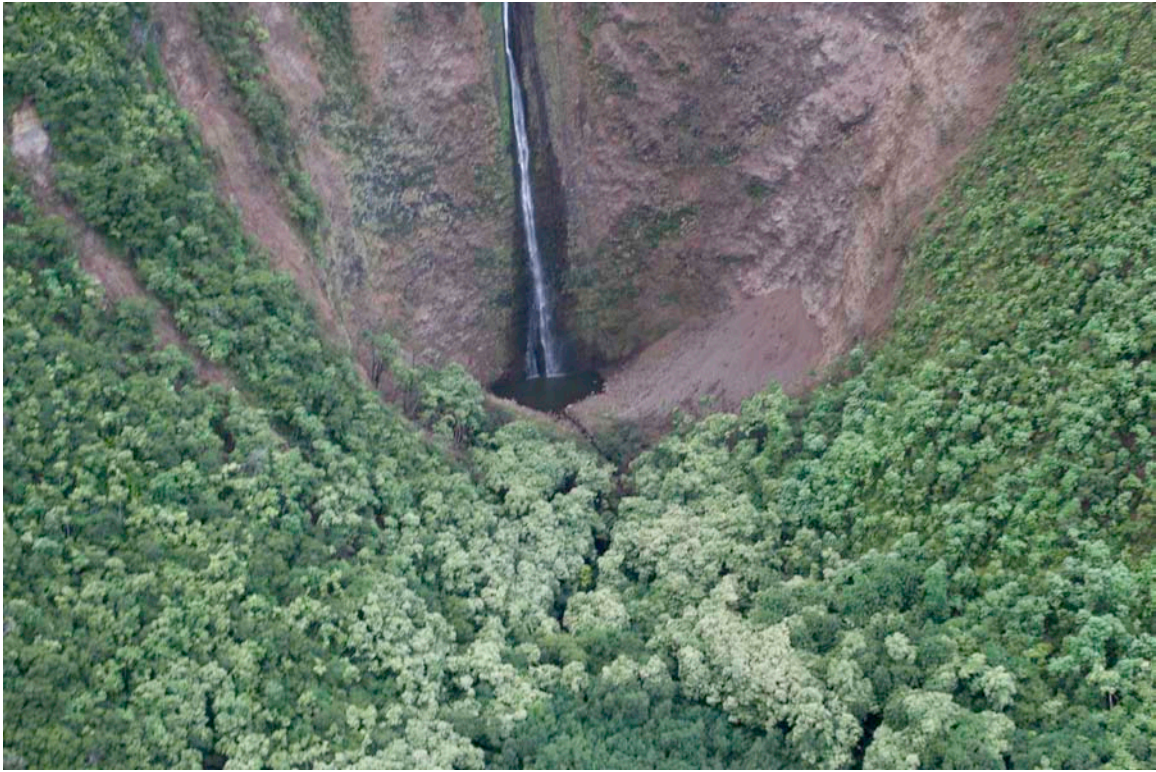
12.5. Close-up aerial view of the bottom of Wai'ilikahi Falls, showing blockage of the stream by rock-slide debris (view to the west). USGS photo by E.L. Harp, 11/8/2006 (elh1188).

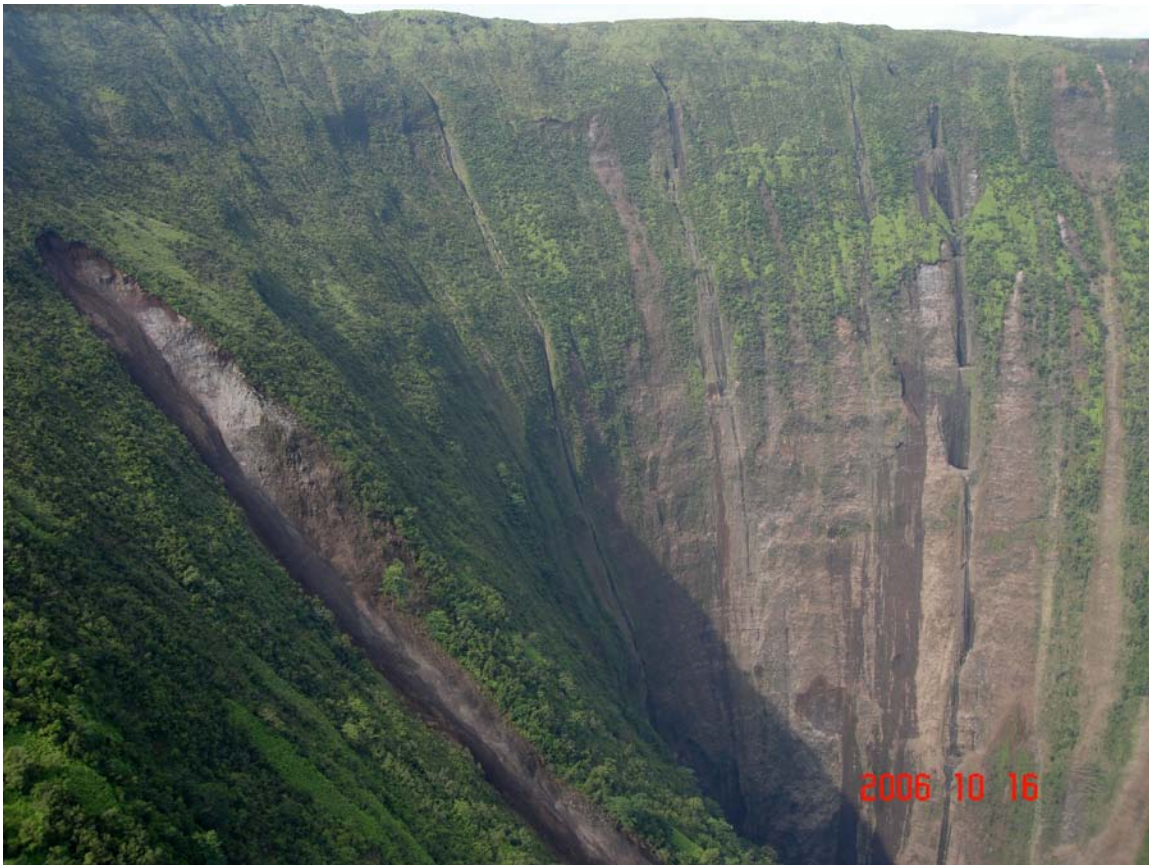
12.6. Aerial view of the shallow rock falls and slides that sheared the high cliffs at the head of Waihilau Branch in Waimanu Valley. Numerous waterfalls feed Waihilau Stream. Note deep scar from a rock slide in the left foreground of the photo (view to the southwest). DLNR photo by S. Bergfeld, 10/16/2006 (sb855).

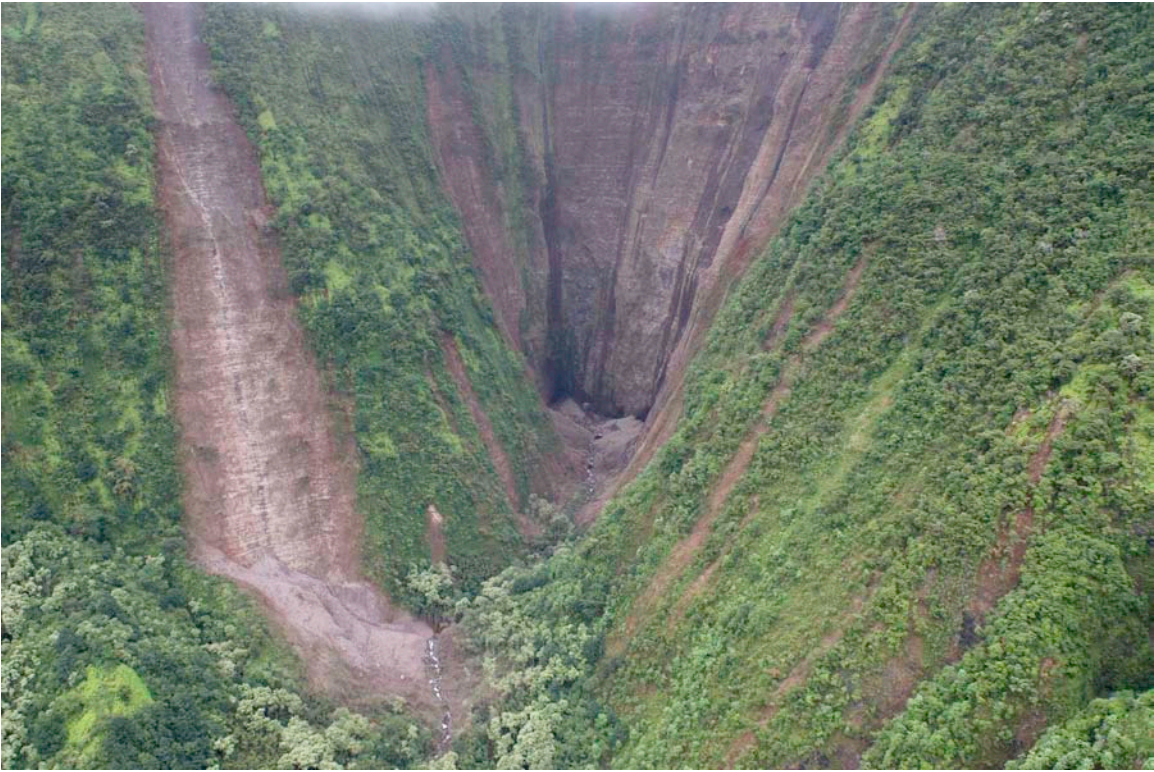
12.7. Close-up aerial view of the walls and rock-slide debris in Waihīlau Branch, Waimanu Valley. The debris that blocked the stream initially was breached subsequently by a large rock slide (view to the southwest). USGS photo by E.L. Harp, 11/8/2006 (elh1177).

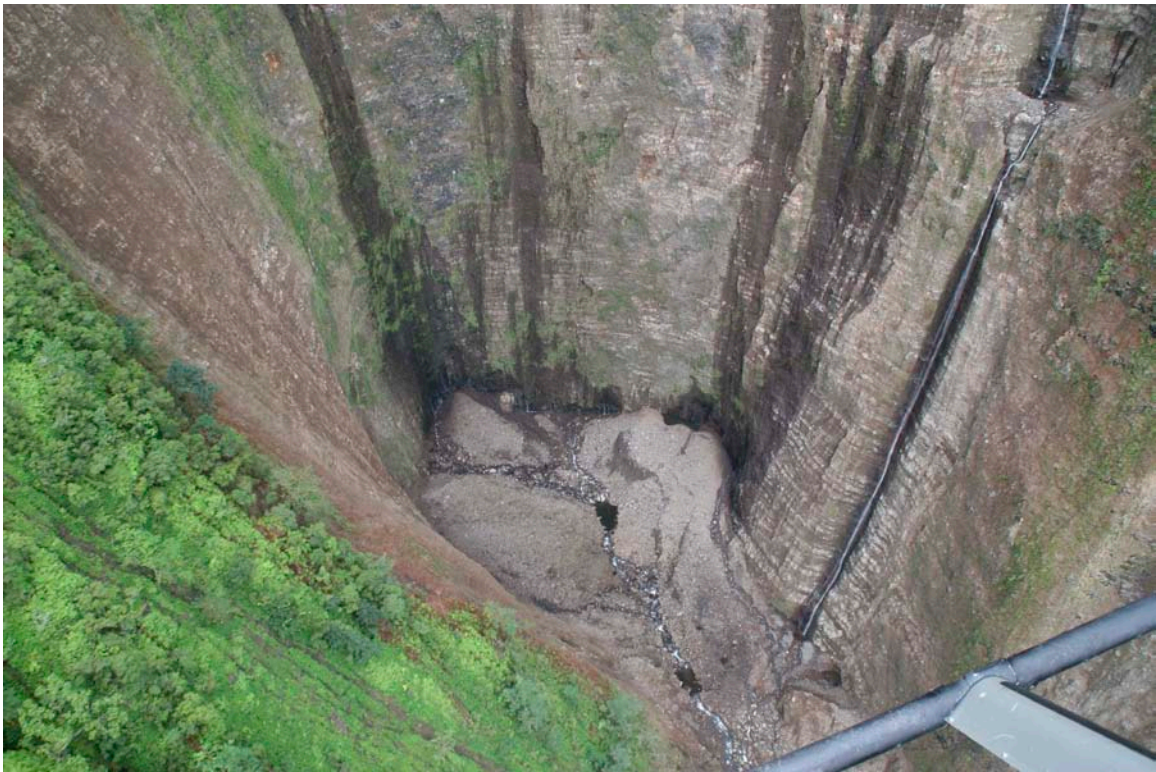
12.8. Close-up aerial view of the scoured cliffs and rock-fall debris in Waihilau Stream at the head of the Waihilau Branch (view to the southwest). USGS photo by E.L. Harp, 11/8/2006 (elh1180).

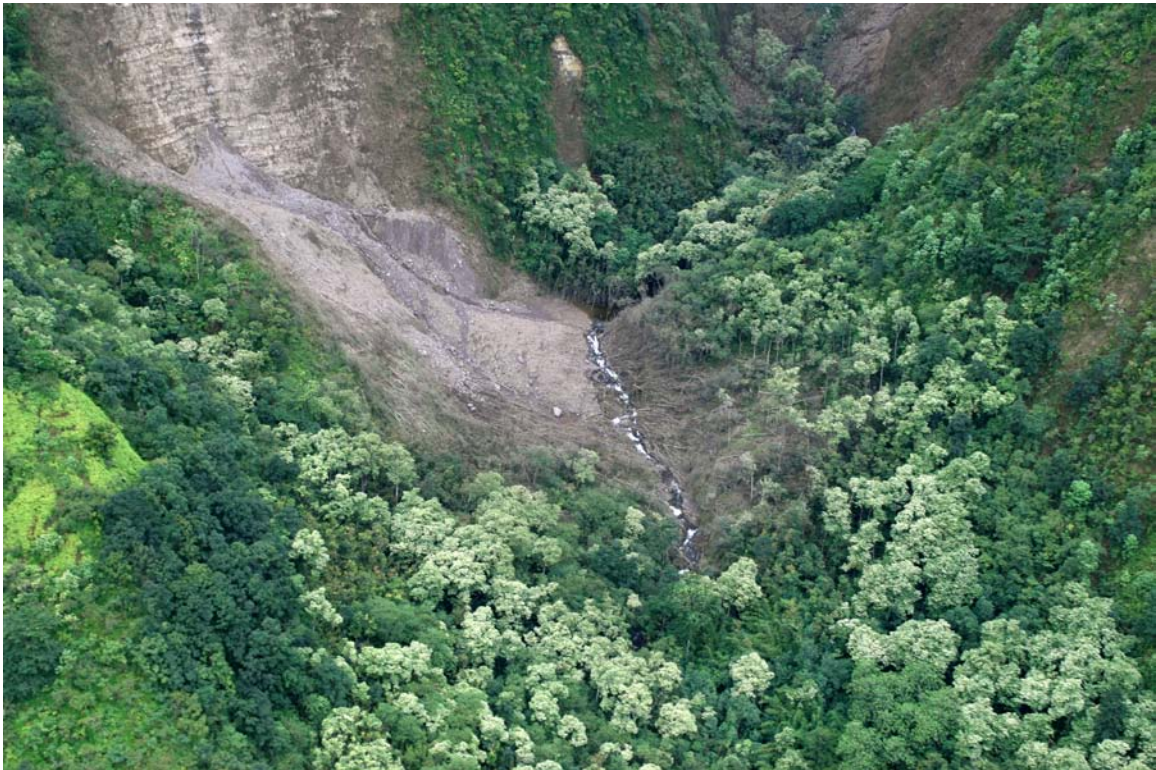
12.9. Close-up aerial view of the large rock slide that breached the dam. Waihilau Stream flows on, over the deposit (view to the southwest). USGS photo by E.L. Harp, 11/8/2006 (elh1176F).

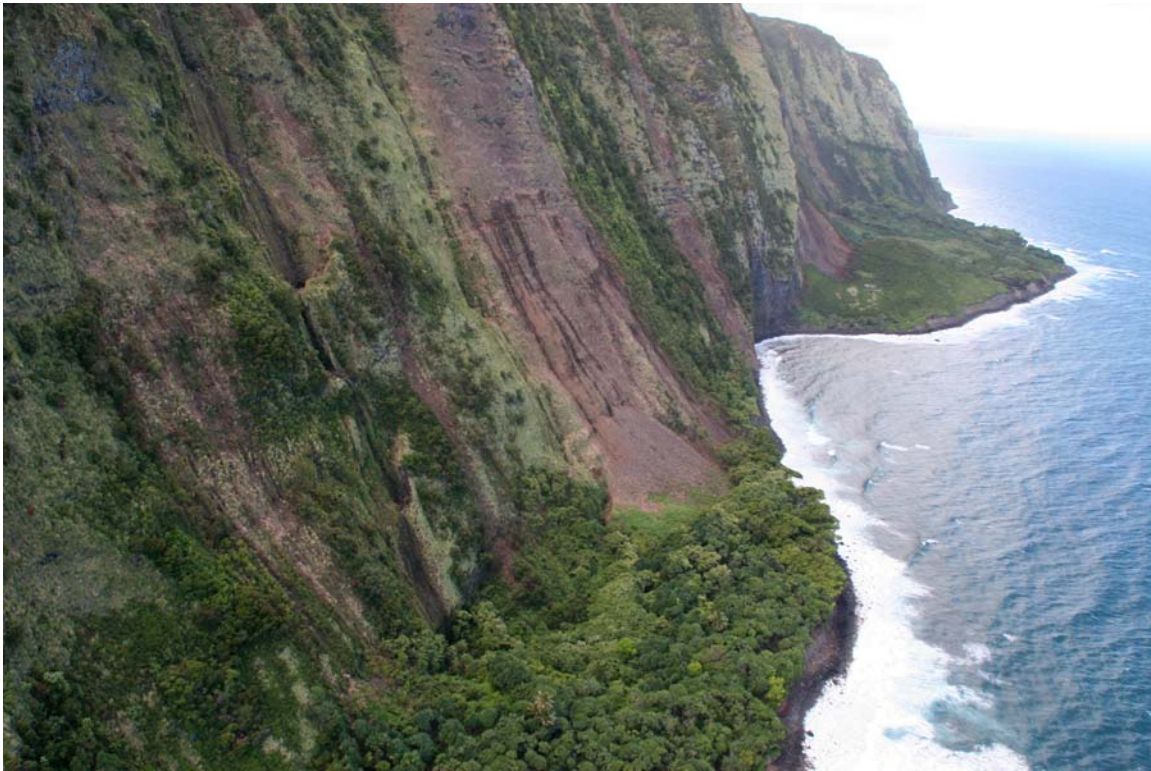
13.1. Aerial view of rock and soil slides from the north end of Laupāhoehoe Iki (in the foreground) to Laupāhoehoe Nui, the larger debris fan, in the background (view to the northwest). USGS photo by E.L. Harp, 11/8/2006 (elh1189).

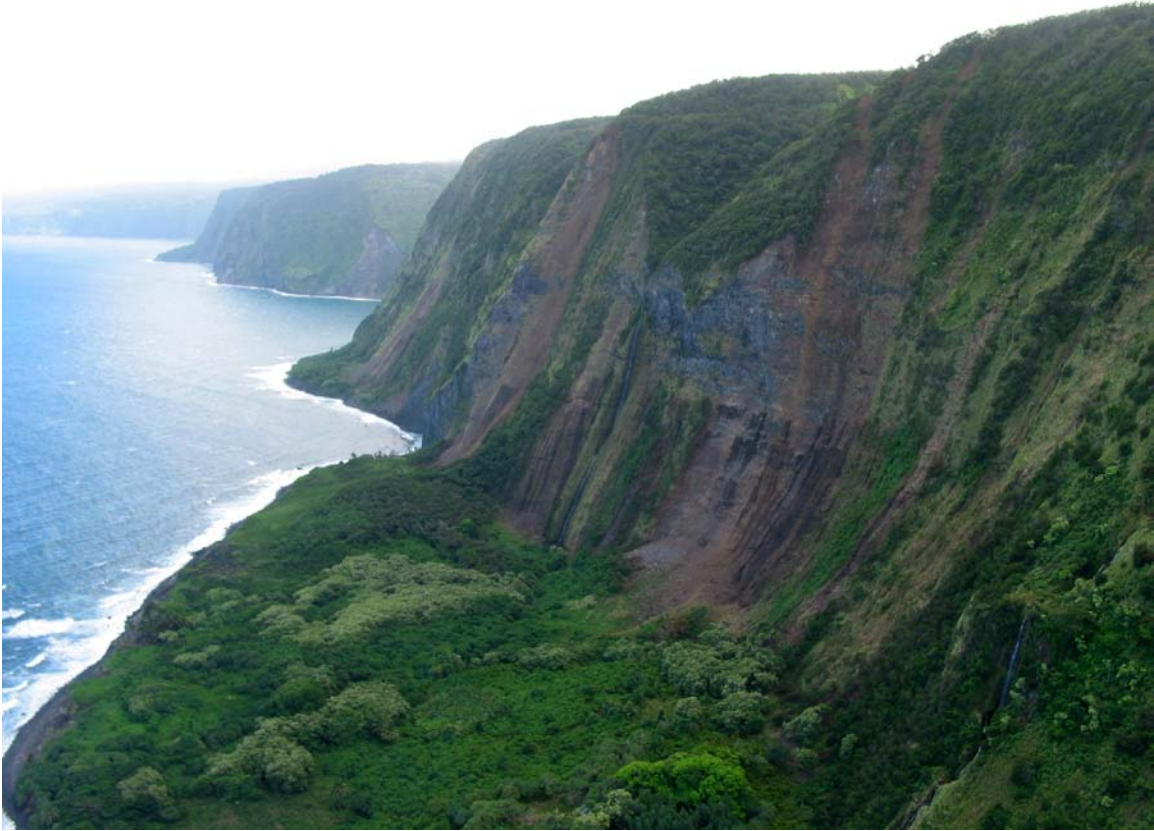
13.2. Aerial view of rock falls and their deposits at Laupāhoehoe Nui (foreground) and Laupāhoehoe Iki (middle ground). The profile of the ‘Āināhou debris fan can be seen in the distance (view to the southeast from the north end of Laupāhoehoe Nui). USGS photo by J.P. Kauahikaua, 11/8/2006 (jpk5954).

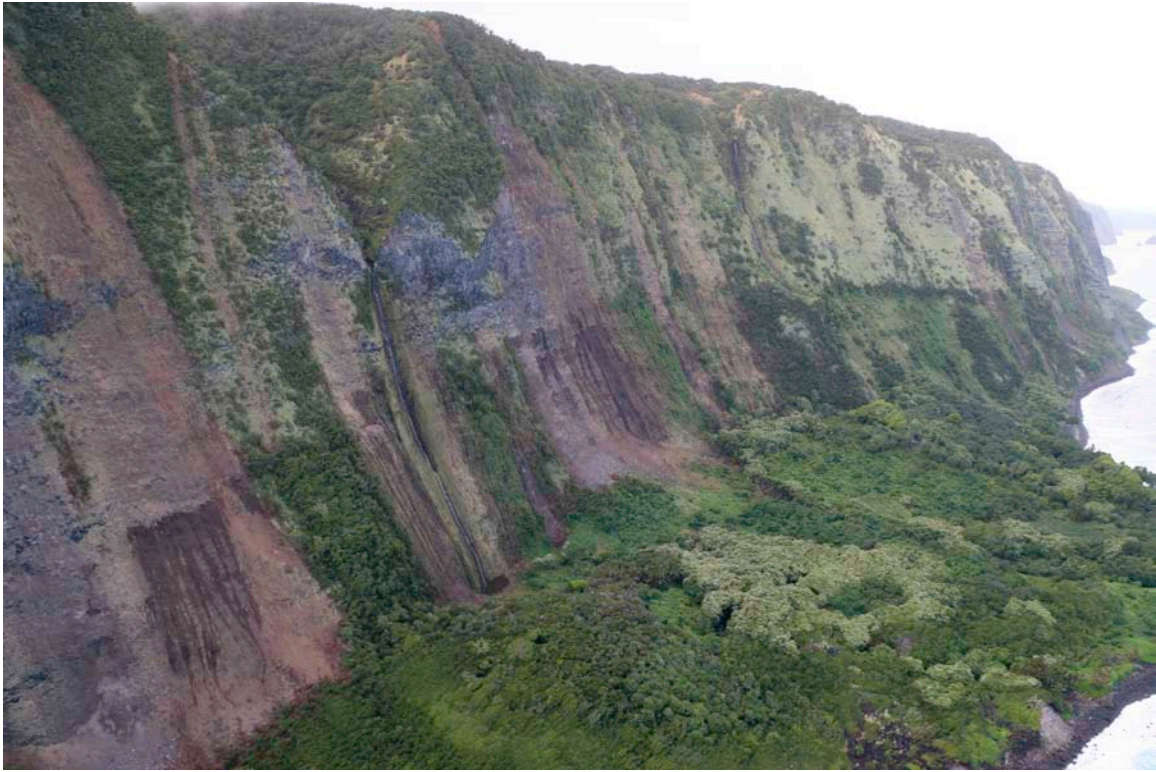
13.3. Aerial view of sea cliffs, abraded by rock falls, and the Laupāhoehoe Nui debris fan, covered with a dense forest of indigenous trees, fed by the rich soil and ash of older rock falls. Groundwater discharge seeps through the saturated land mass and drips down from the lower third of the sea cliff (view to the west). USGS photo by E.L. Harp, 11/8/2006 (elh1191).
